# Debris/Ice/TPS Assessment and Integrated Photographic Analysis for Shuttle Mission STS-62

(NASA-TM-109201) DEBRIS/ICE/TPS  
ASSESSMENT AND INTEGRATED  
PHOTOGRAPHIC ANALYSIS FOR SHUTTLE  
MISSION STS-62 Final Report, 2-21  
Mar. 1994 (NASA. Kennedy Space  
Center) 138 p

May 1994

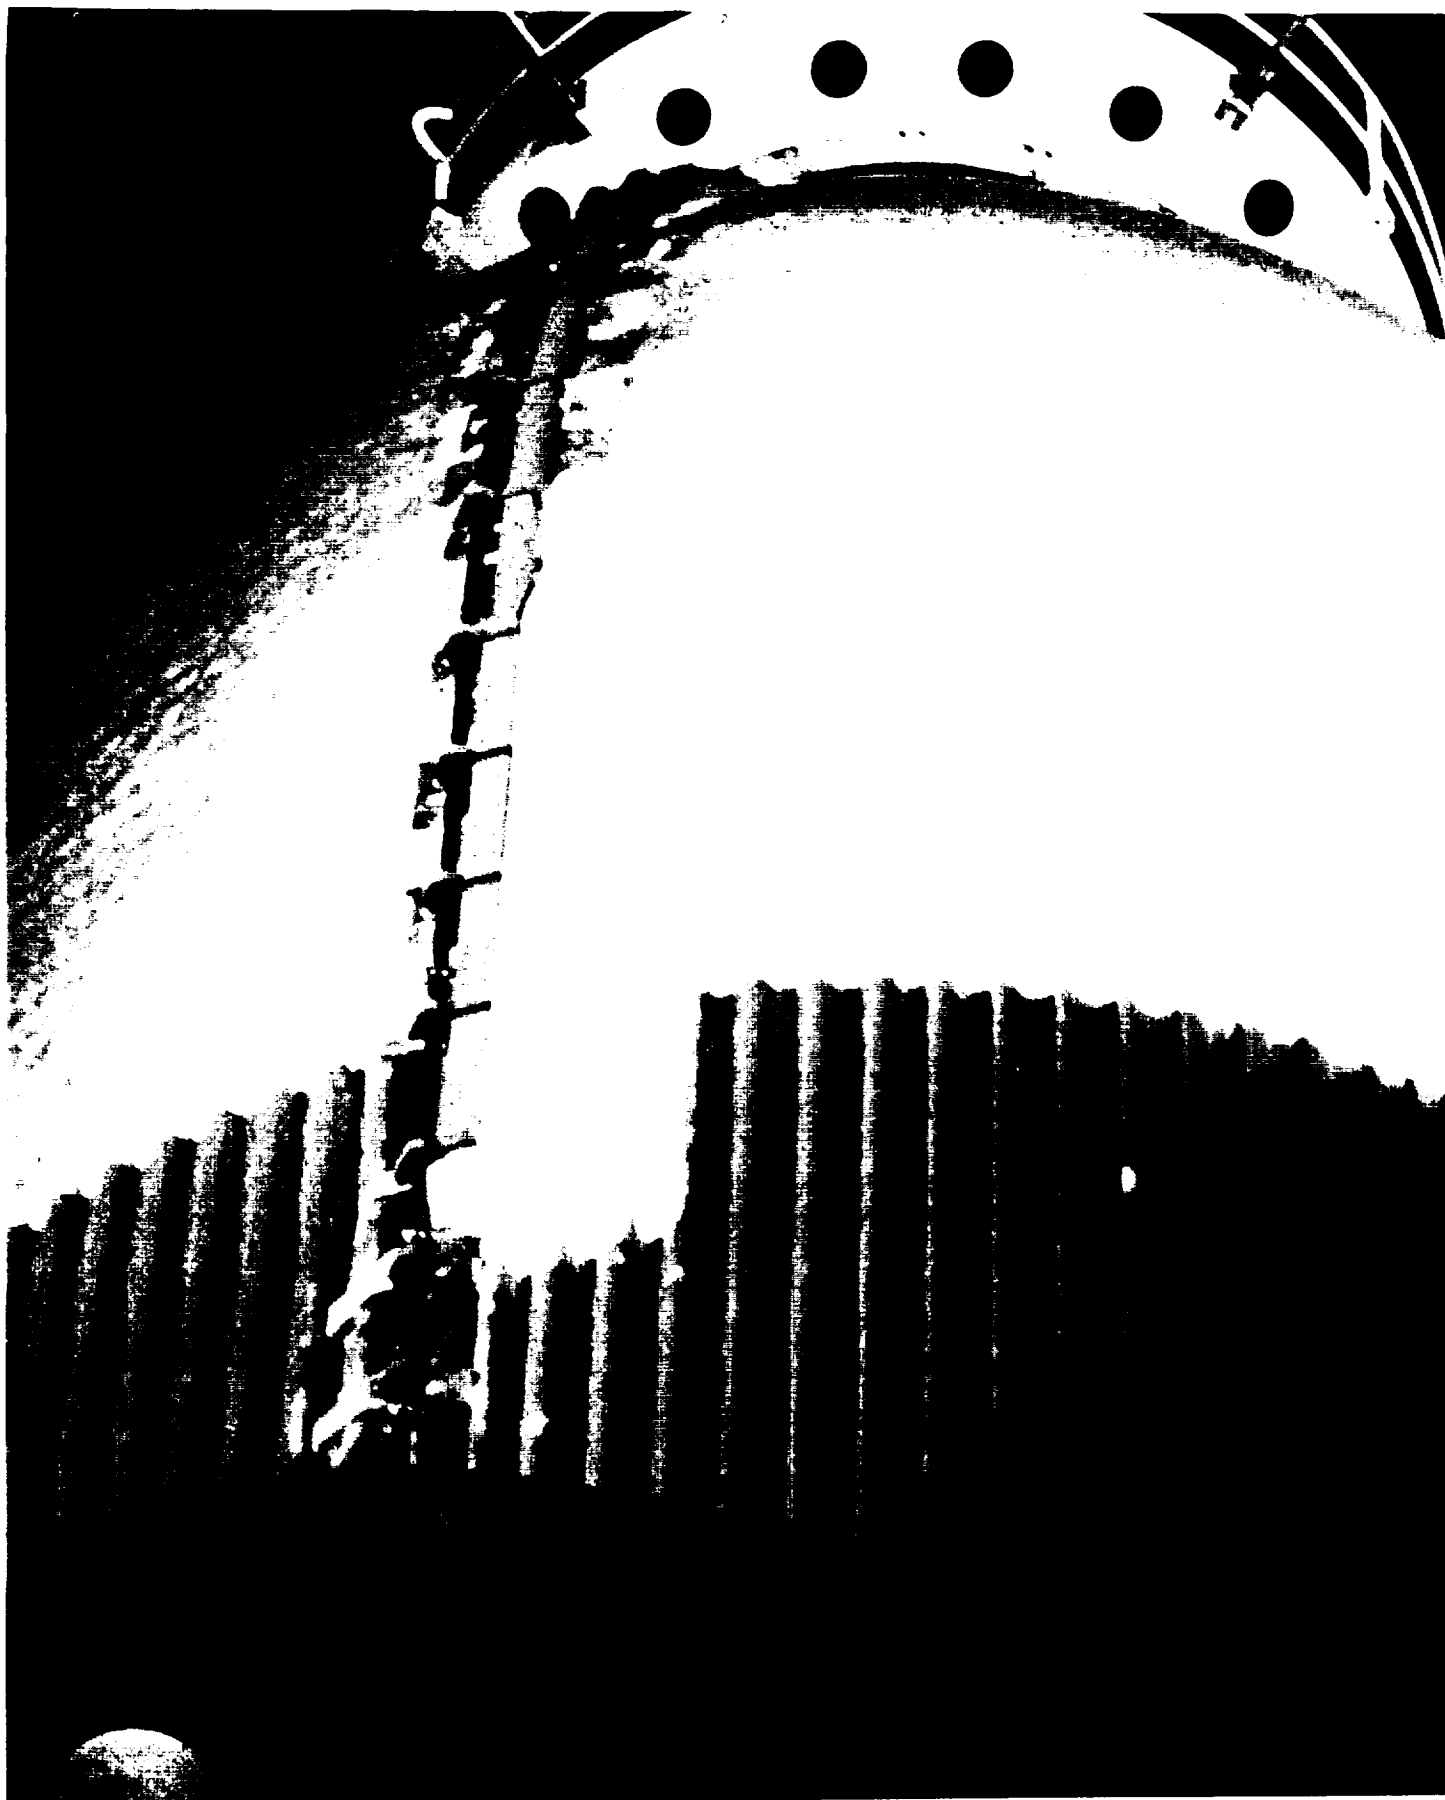
Frost, but no ice, had generally formed on the L02 tank barrel +Y+Z quadrant. There was no ice or frost in the "No Ice" region on the nosecone and ogive.

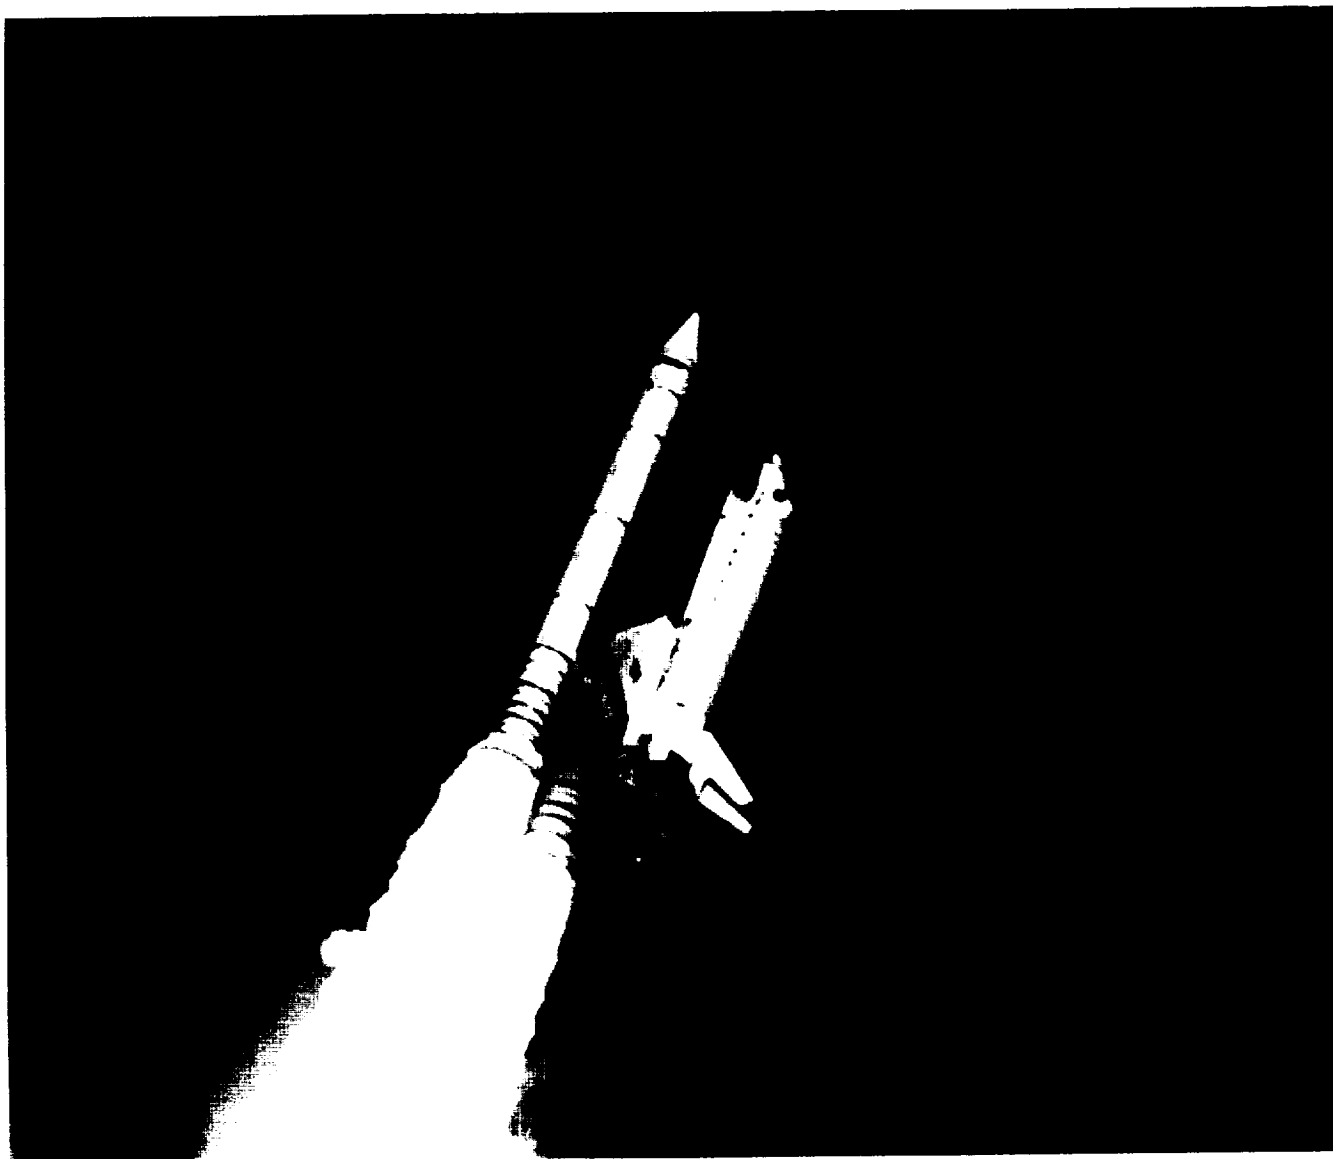
The LO2 T-0 umbilical disconnected from the Orbiter properly. A rectangular object (arrow), most likely a parts tag, fell from the carrier plate at 13:52:55.514 GMT.

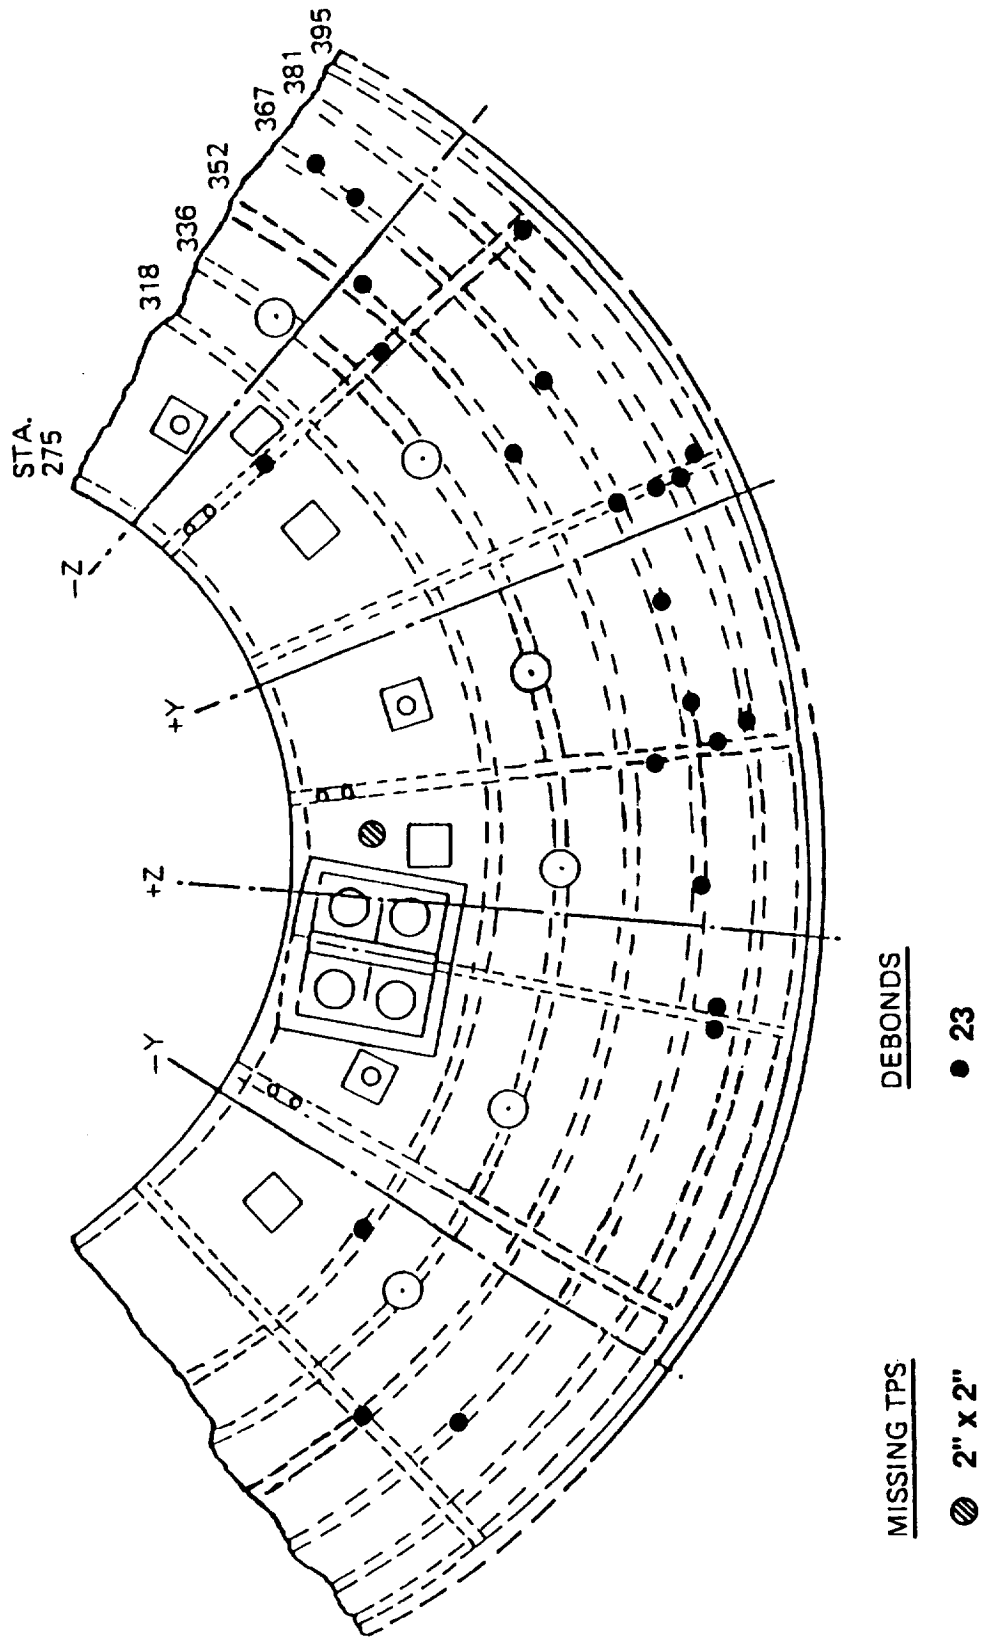
FIGURE 4. RIGHT SRB FRUSTUM

The RH frustum was missing one 2" x 2" area of TPS near the BSM's and had 23 MSA-2 debonds over fasteners. Significant amounts of BTA had been applied to closeouts on this frustum. Hypalon paint was blistered/missing from areas where the BTA had been applied. The underlying BTA was not sooted except along the 395 ring aft of the BSM cluster. The soot pattern indicated some of the blisters may have formed prior to SRB separation (IFA STS-62-B-1). Investigation of this condition concluded there was insufficient heat rates to cause blistering of the Hypalon until late in the ascent phase. Testing has shown that Hypalon blisters burn off rather than become detached debris sources. The BSM aero heat shield covers had locked in the fully opened position though three of the attach rings had been bent by parachute riser entanglement (Figure 4).

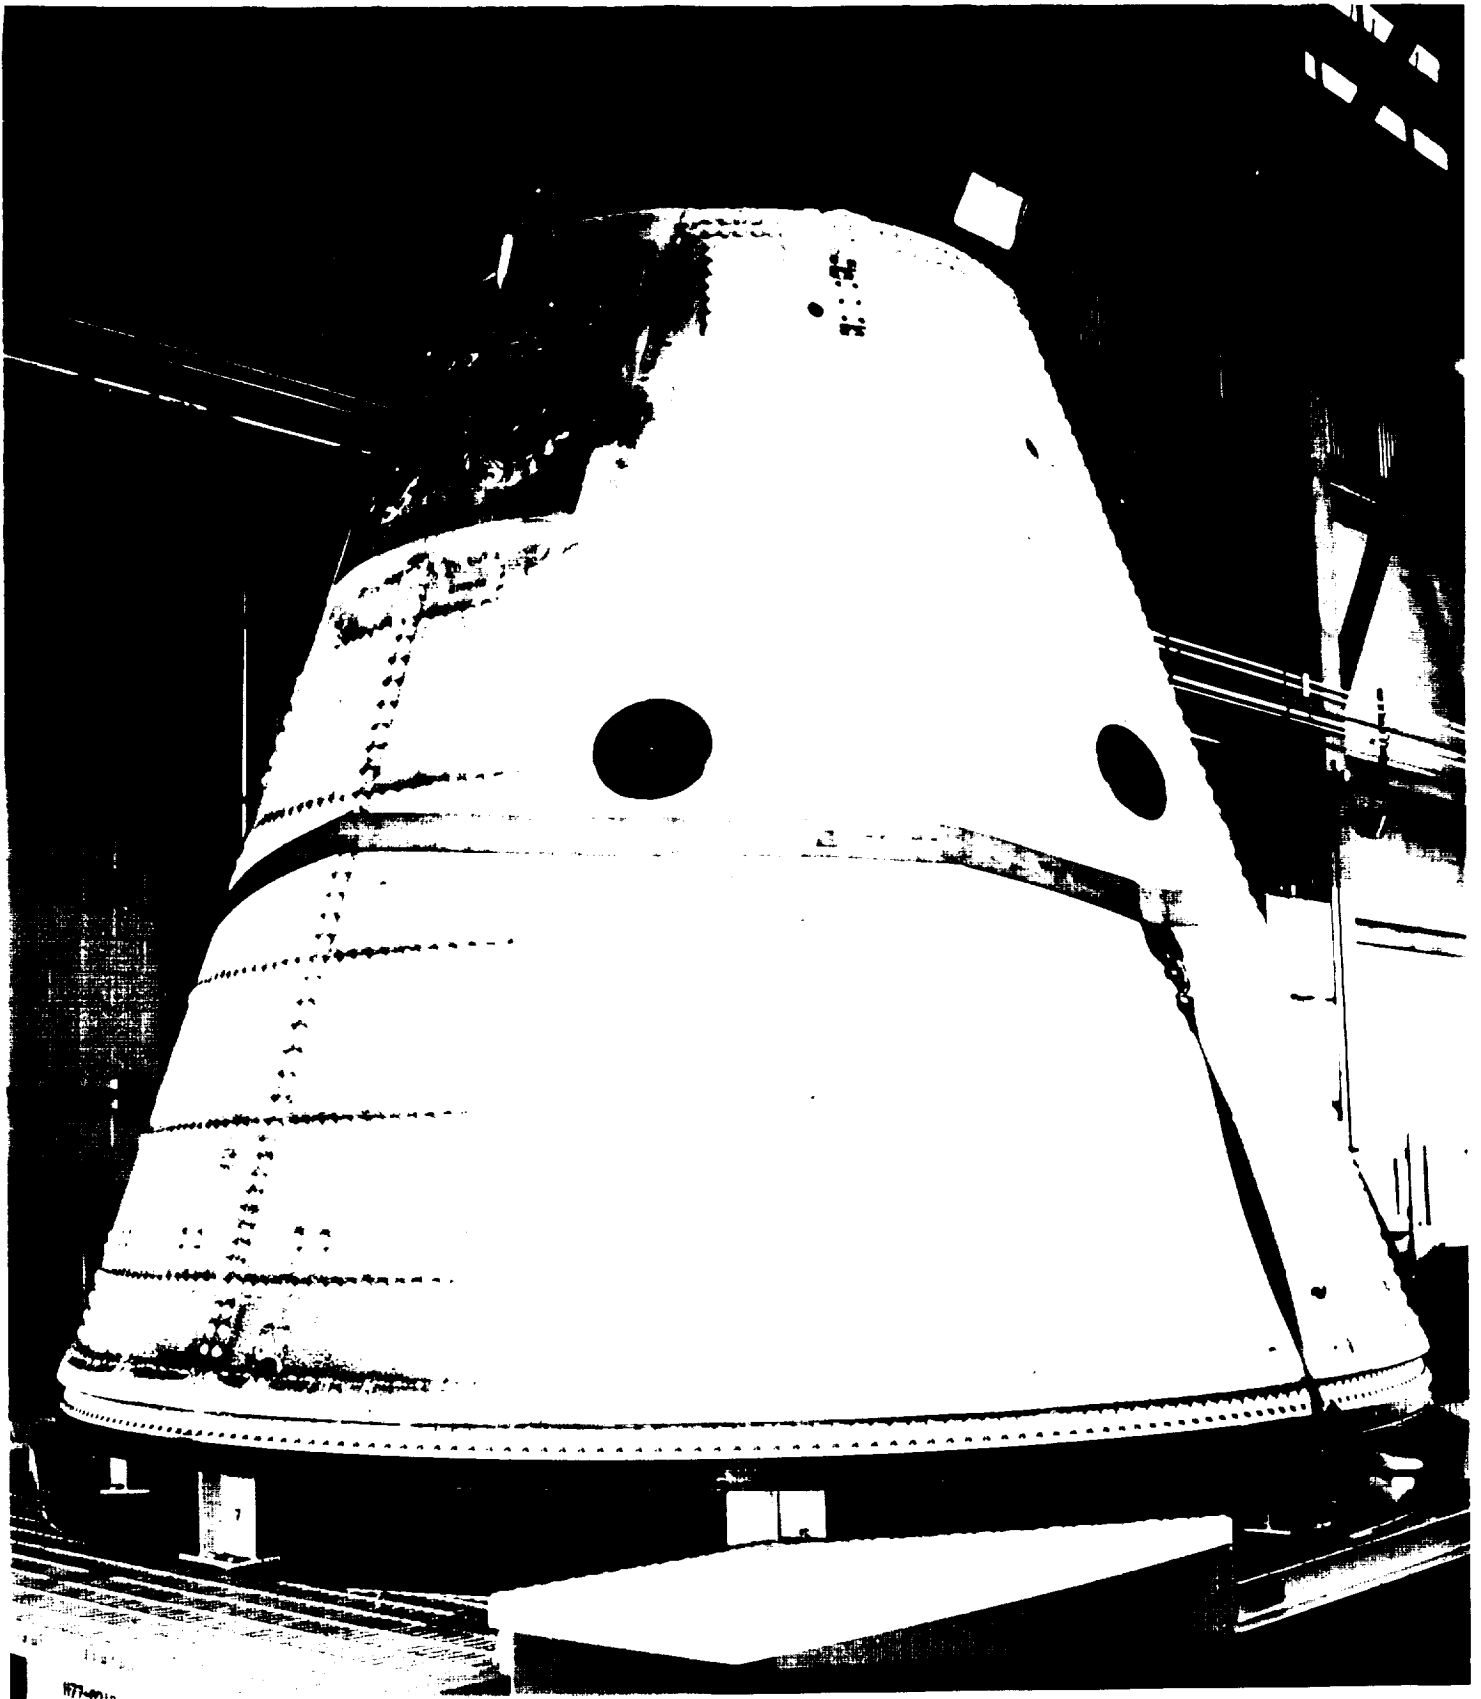
The RH frustum had 23 MSA-2 debonds over fasteners. Hypalon paint was blistered/missing from the areas where BTA had been applied. The BSM aero heat shield covers had locked in the fully opened position.

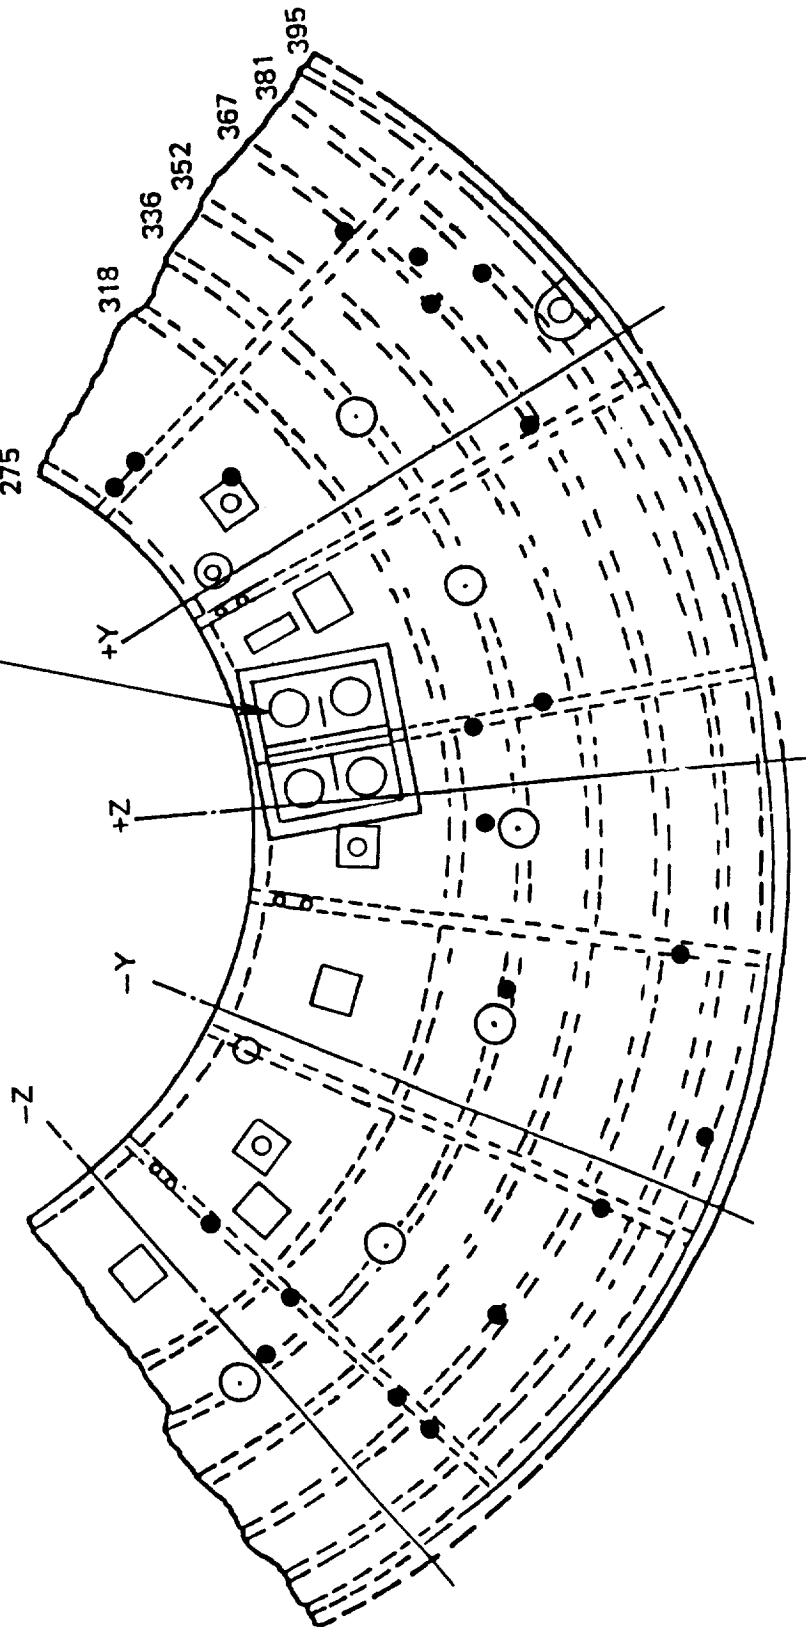
FIGURE 5. **LEFT SRB FRUSTUM**  
COVER ROTATED APPROXIMATELY  
20 DEGREES CCW

The LH frustum upper left BSM cover was bent backward to the 90 degree position and the attach ring had been deformed/fractured by parachute riser entanglement. The upper right BSM cover had rotated 20 degrees counterclockwise when the set screw holding the BSM in position was overloaded by parachute riser entanglement. The HDP #8 DCS plunger had been pushed back into the plunger housing, but was not obstructed by frangible nut pieces. Although launch films showed no debris falling from the DCS/stud hole at lift off, post flight disassembly of the Debris Containment System revealed a retention of only 77 percent. The ordnance fragments may have been lost at water impact.

The LH frustum was missing TPS in one area (3"x2") near the -Y axis/275 ring frame and had 21 MSA-2 debonds over fasteners. There was virtually no blistering of the Hypalon paint with the exception of minor localized blistering along the 395 ring. All BSM aero heat shield covers had locked in the fully opened position. However, the left covers were bent backward and the attach rings had been deformed/fractured by parachute riser entanglement. The upper right BSM had rotated 20 degrees counterclockwise when the set screw holding the BSM in position was overloaded due to parachute riser entanglement (Figure 5).

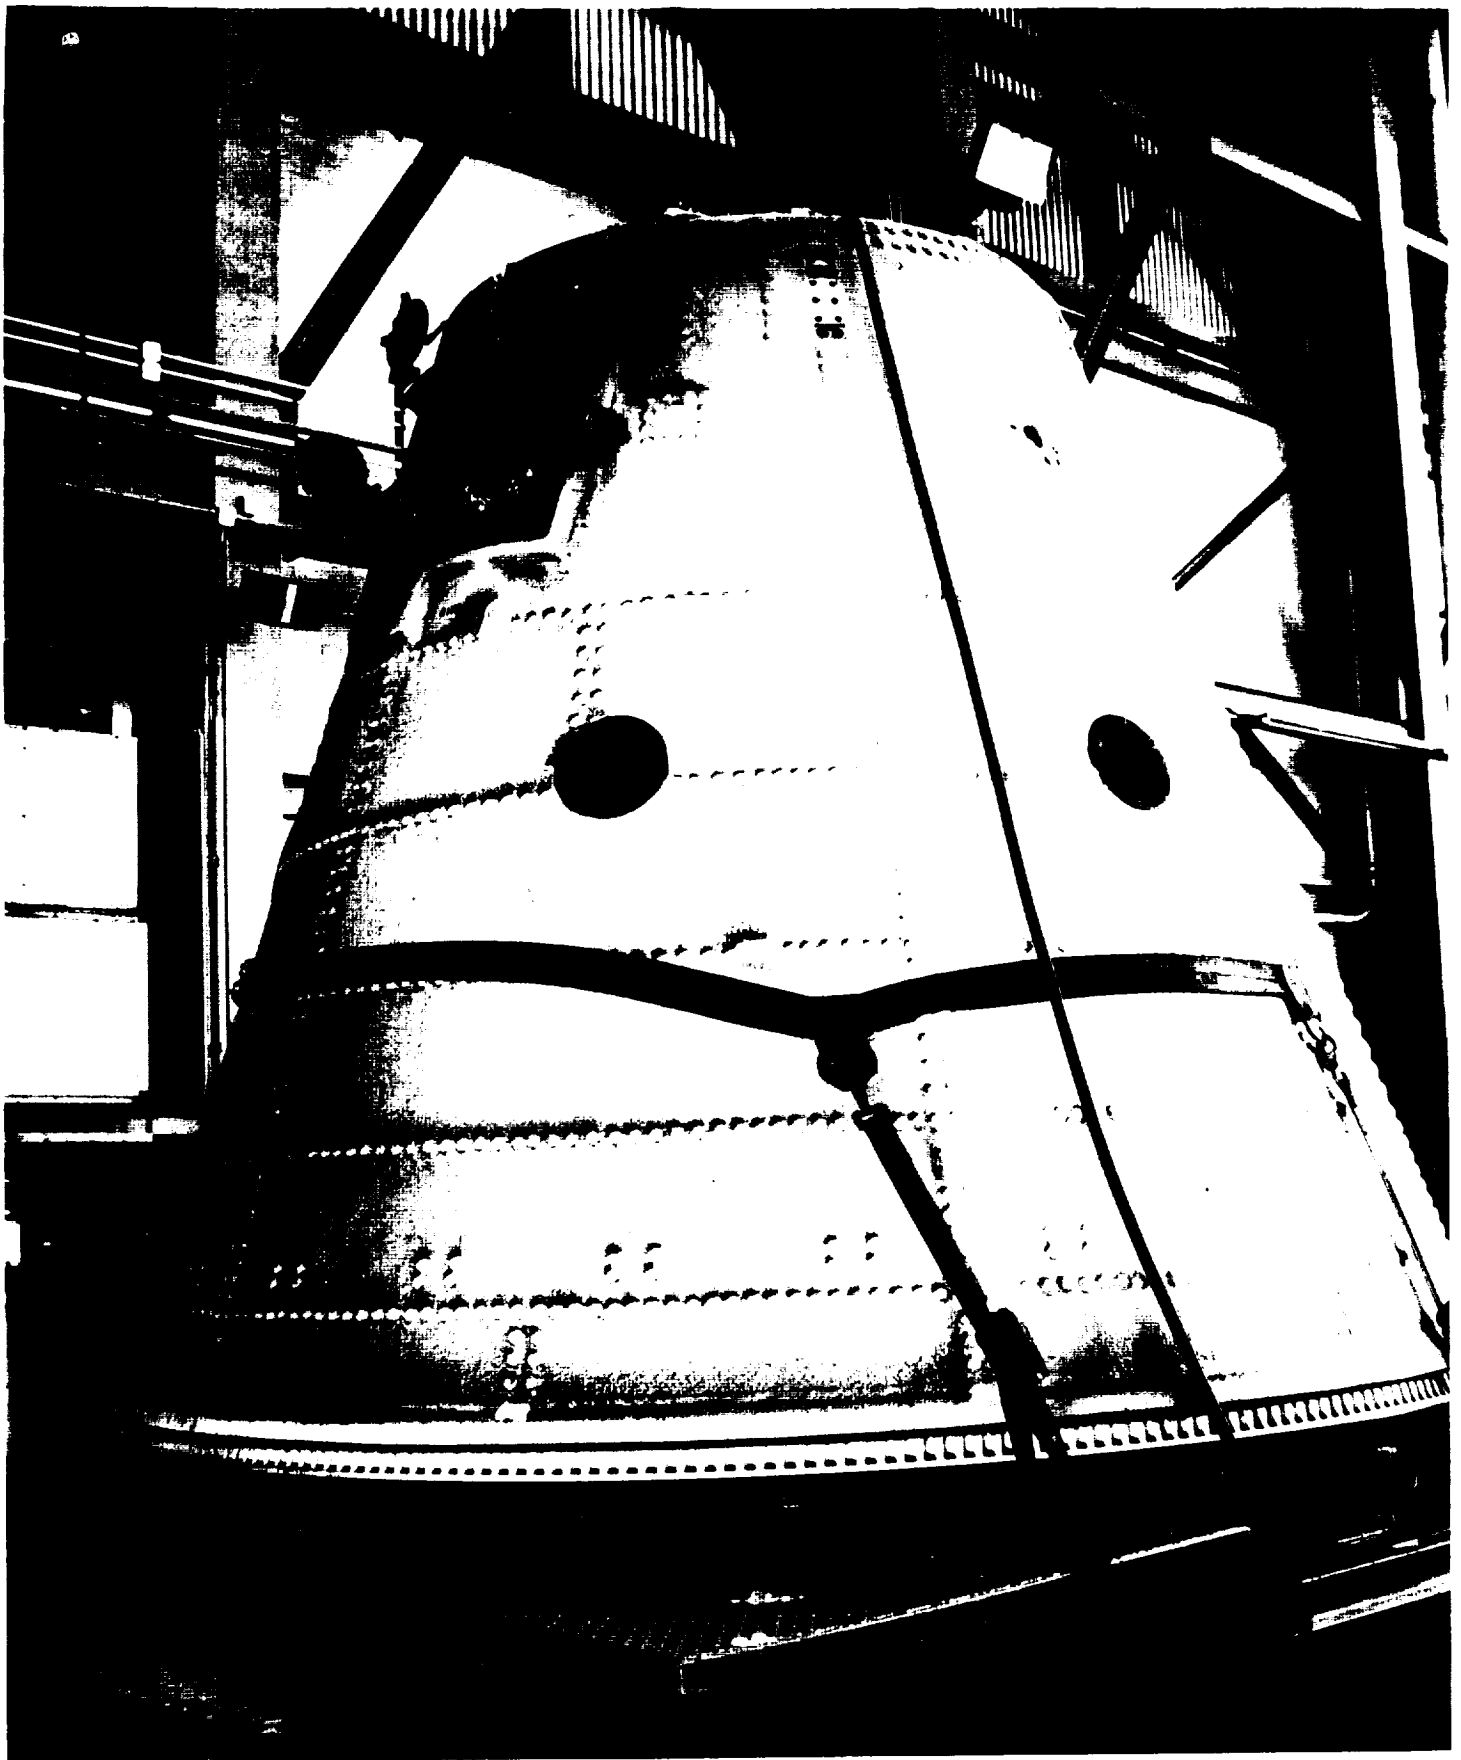
The LH frustum had a total of 21 MSA-2 debonds over fasteners. All BSM aero heatshield covers had locked in the fully opened position, though both left cover attach rings had been bent by parachute riser entanglement.

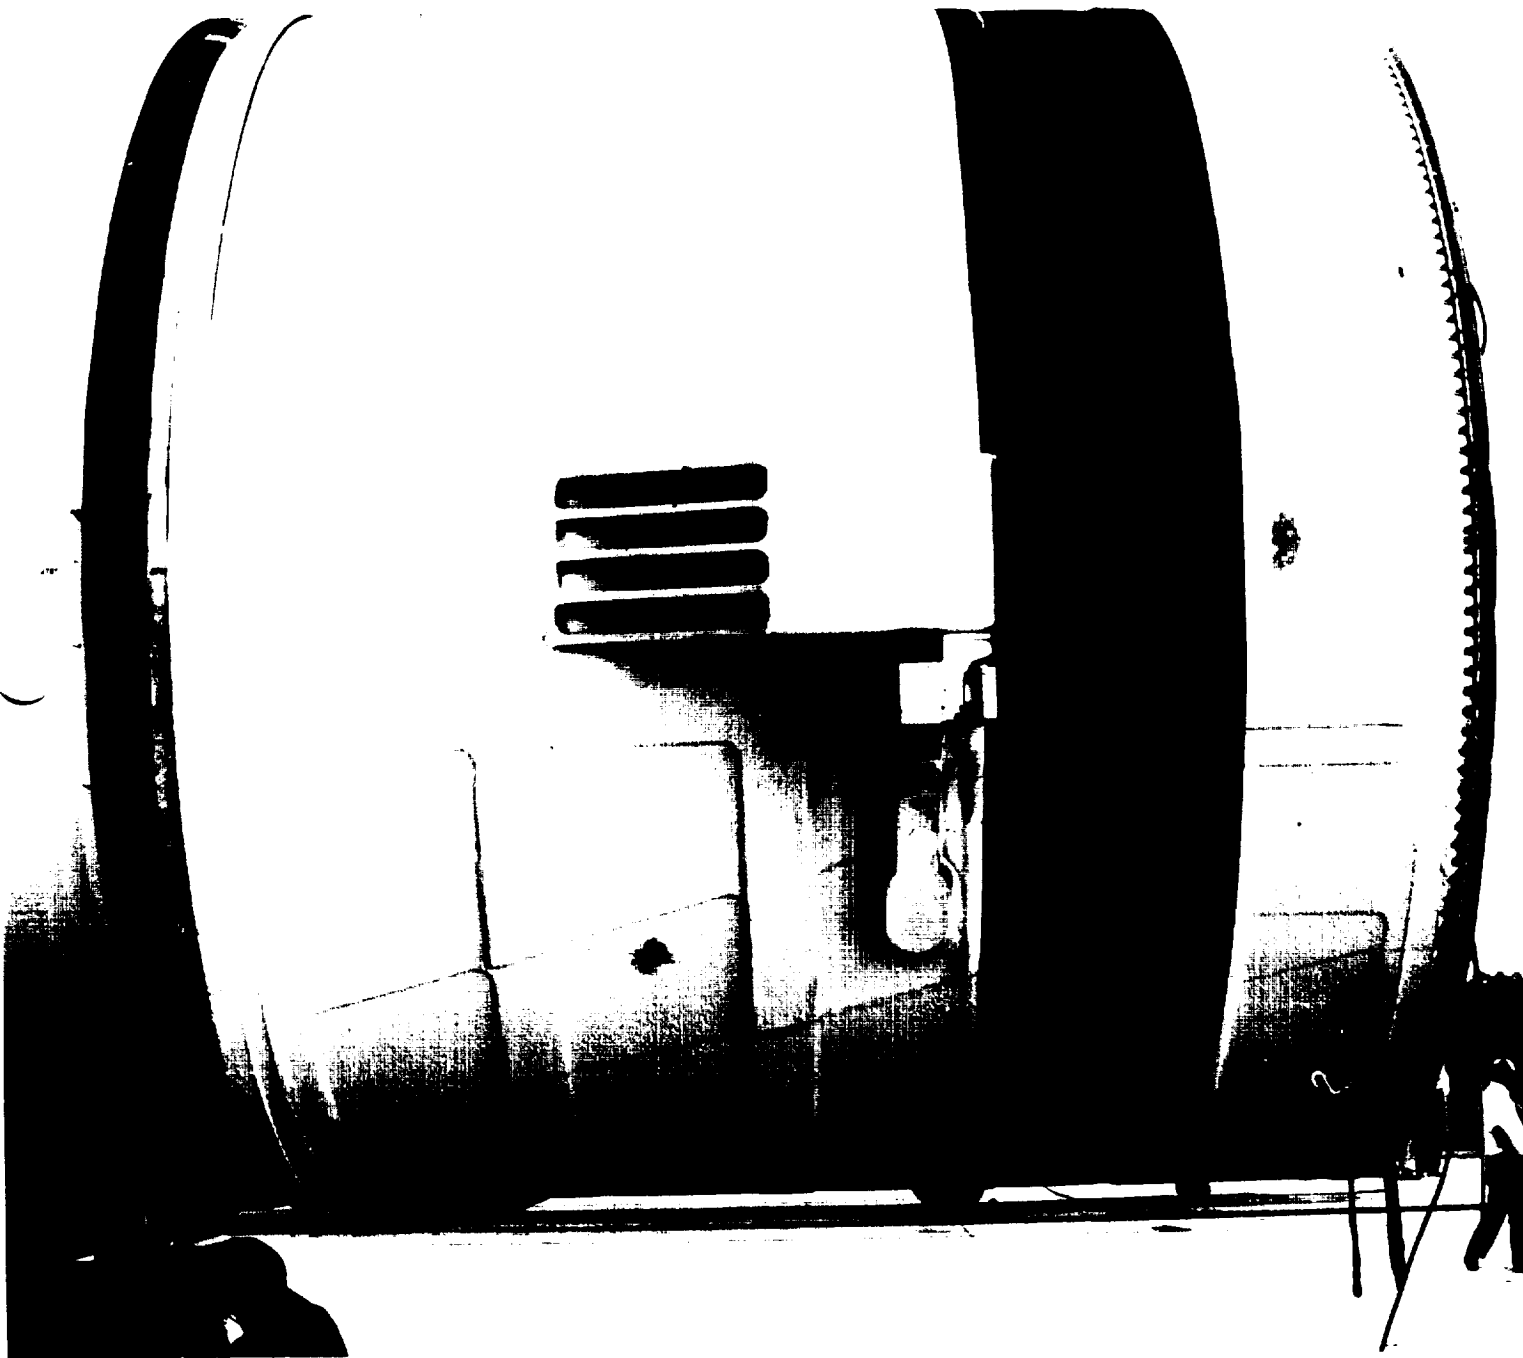
The upper right BSM had rotated approximately 20 degrees counterclockwise. Post flight assessment revealed the set screw holding the BSM in position had been overloaded by parachute riser entanglement.

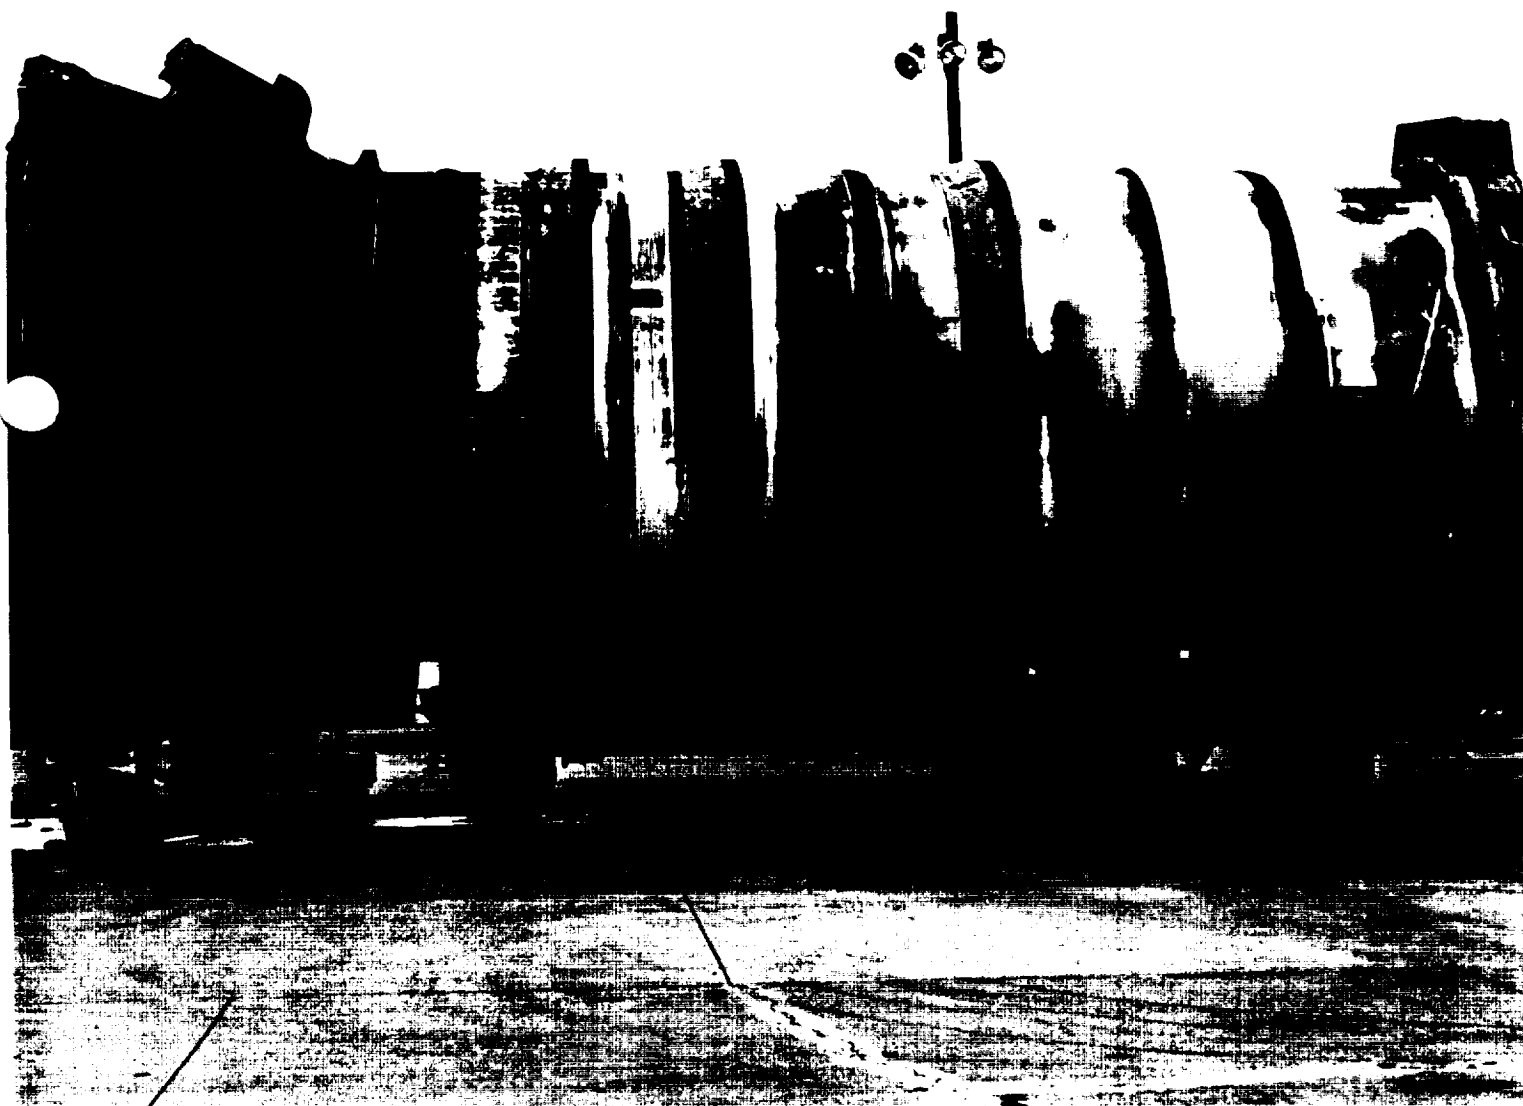
The LH forward skirt acreage MSA-2 exhibited no debonds or missing TPS. Both RSS antenna covers/phenolic base plates were intact though the -Z antenna base plate was delaminated.

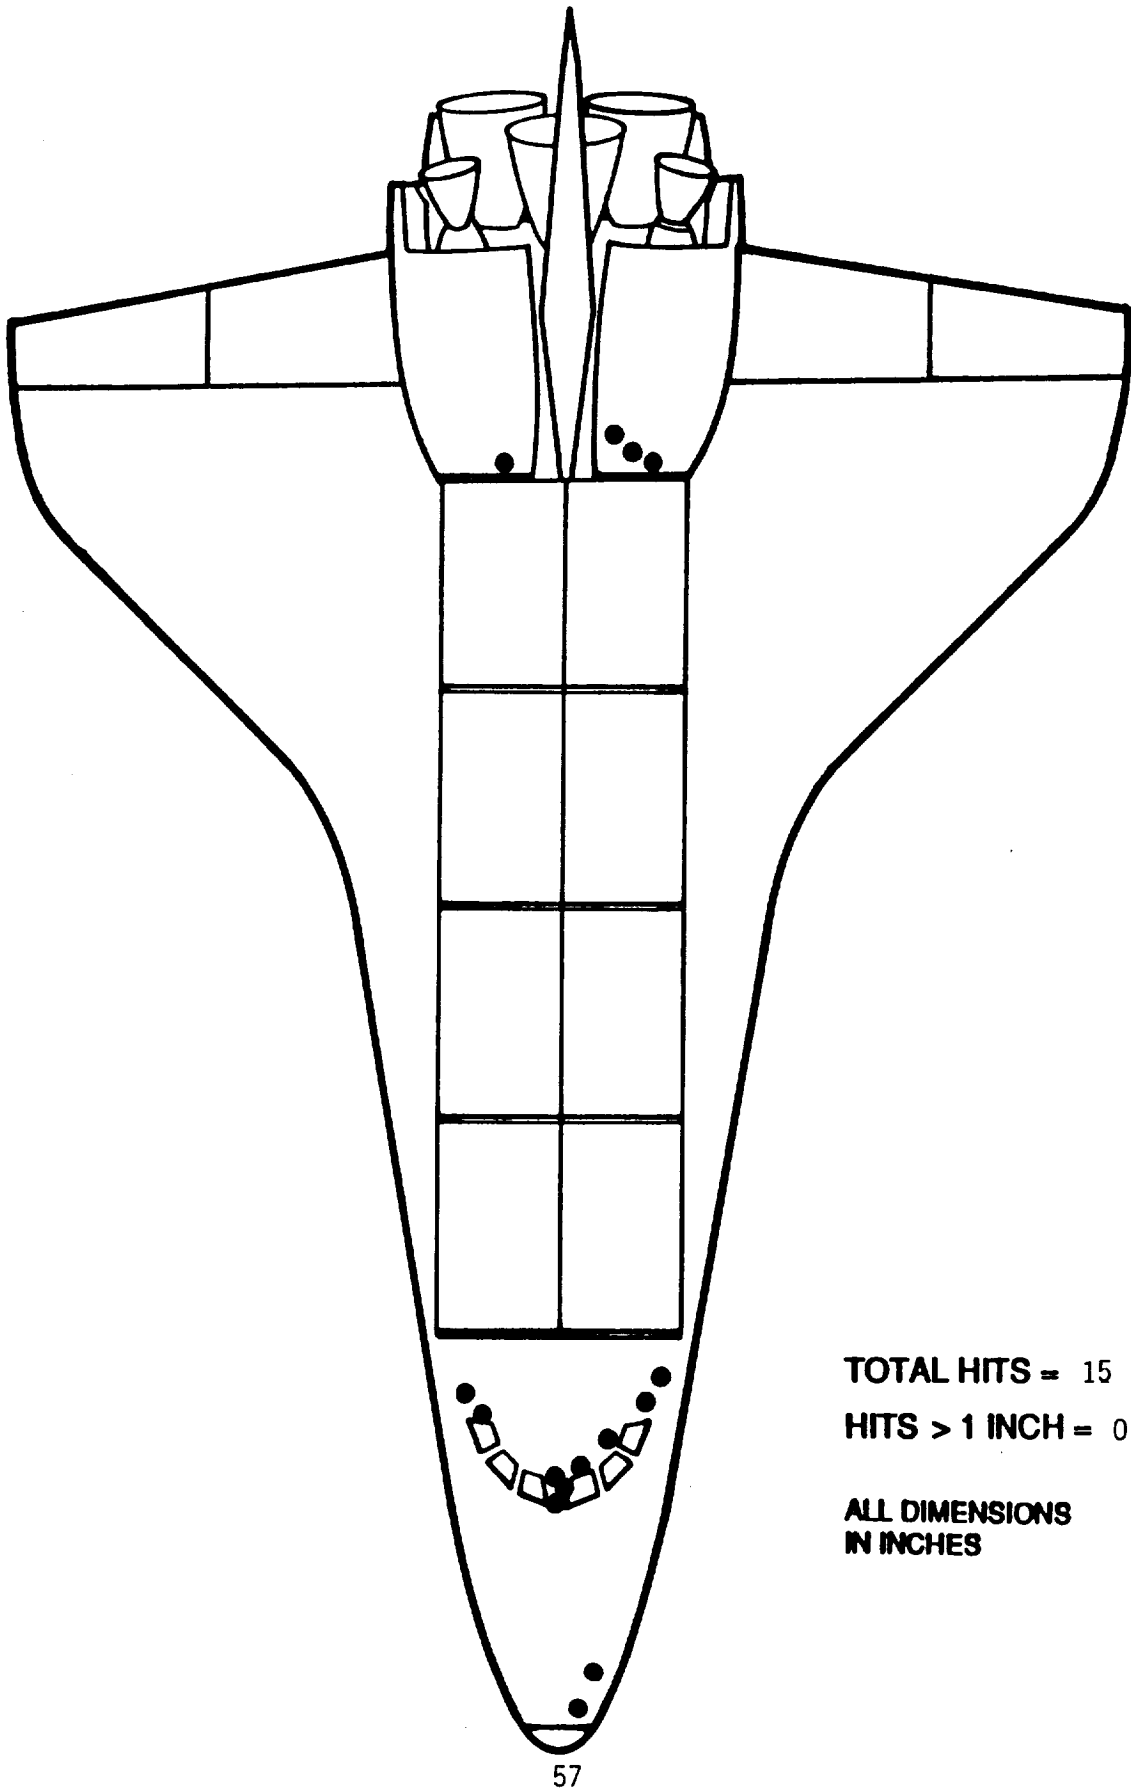
FIGURE 9. **DEBRIS DAMAGE LOCATIONS**

A cluster of 29 damage sites spanned three tiles on the rudder black edge tiles (left side) along the hinge line below the split in the speed brake. Six of the damage sites had a major dimension of 1-inch or larger while three of the damage sites were deep enough to expose the substrate. Three small hits occurred in this same general area on the right side of the rudder/speed brake.

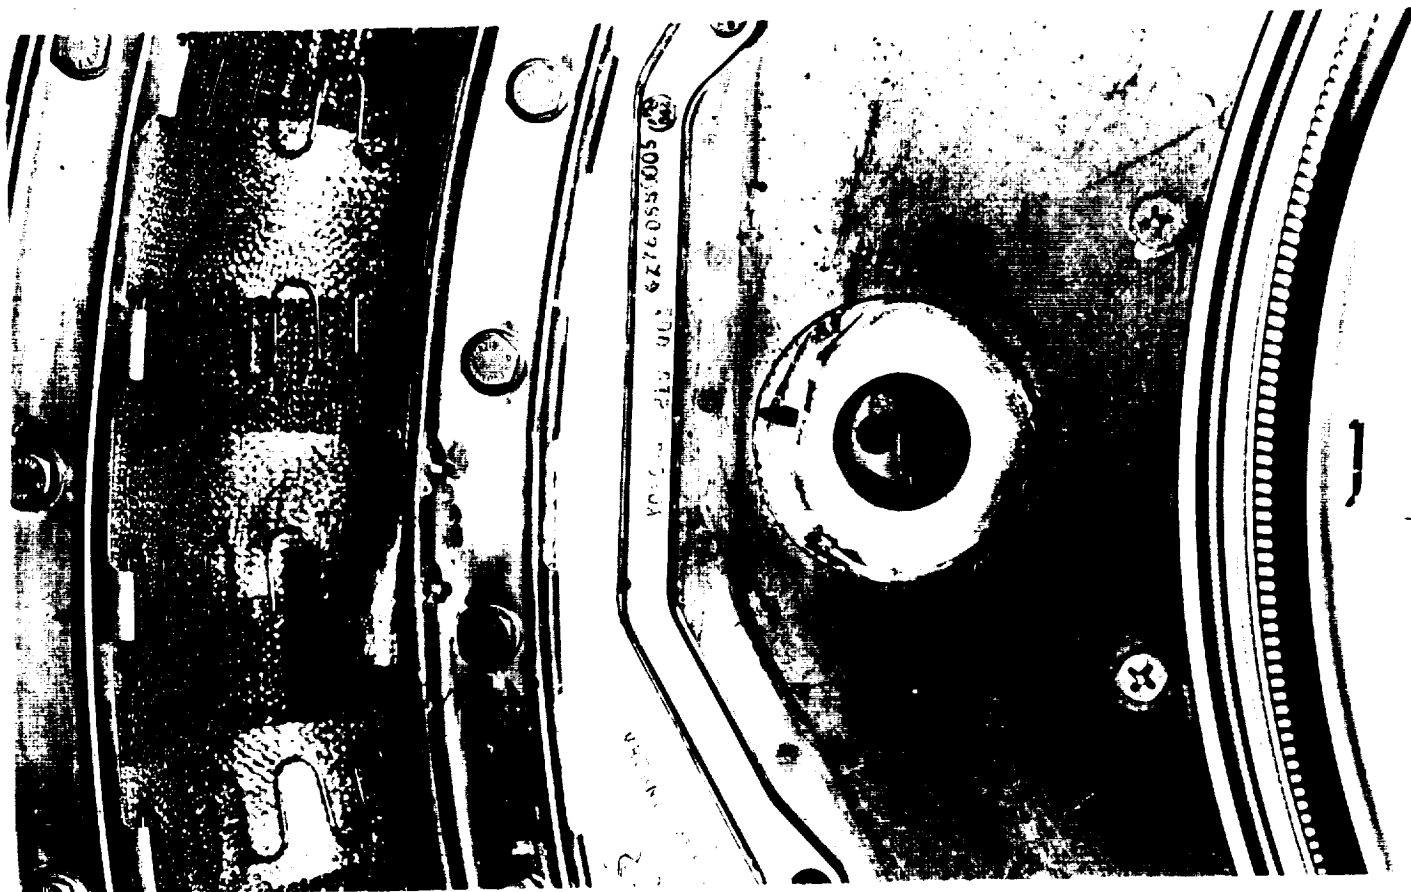
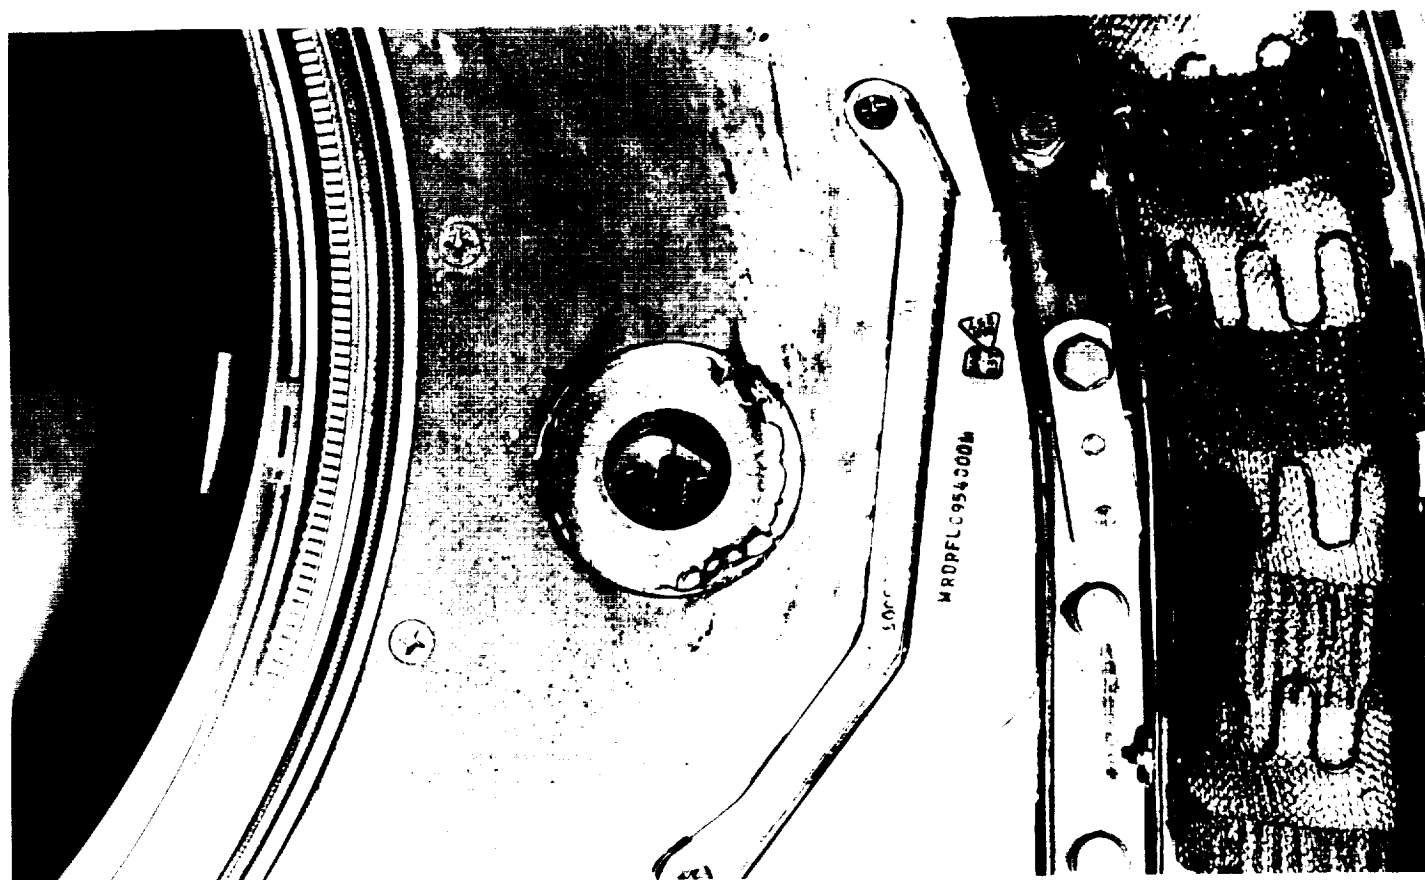
Charred white RTV protruded from the LH2 ET/ORB umbilical forward outboard and forward inboard pyrotechnic canister to umbilical plate interfaces.

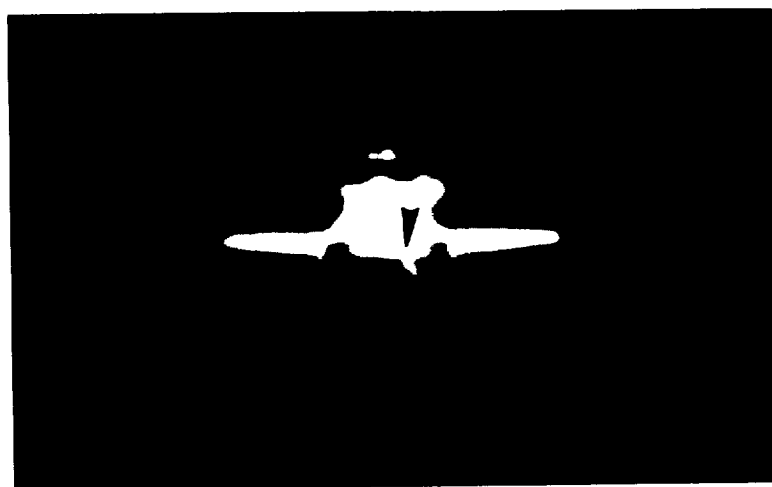
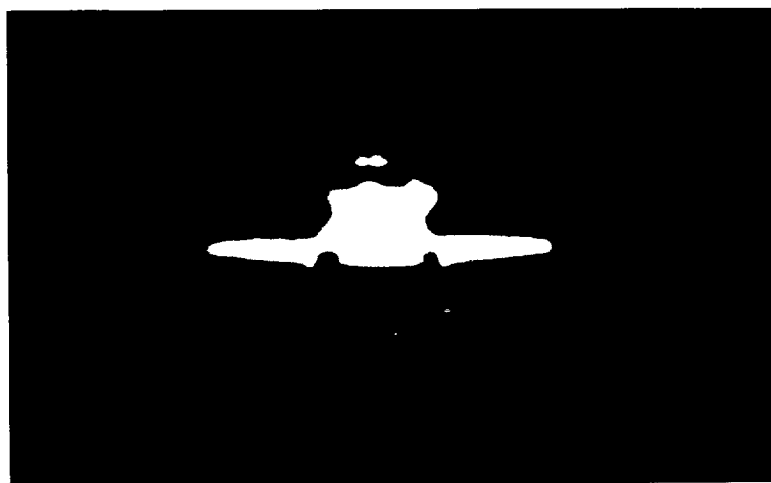
A search of the area under the flight path failed to recover the missing thermal barriers, which may be submerged in the large body of water south of the runway. The cause for the loss of the material was attributed to the way the substrate was prepared for bonding at the vendor.

Thermal barrier, as large as 36 inches in length, fell from the Orbiter nose wheel well as the landing gear door opened on final approach. The thermal barrier, which was still at an elevated temperature from re-entry, was clearly visible in the infrared views but virtually invisible in the landing films.
